## KPF 2023 OBE Update #5, 4th of August, 2023

#### Water Flow Rates

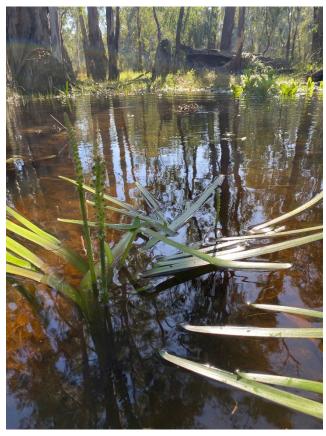
Figure 3. Water ribbon in flower at Crooked Creek, 03/08/23

- The ecological response is now evident throughout the whole forest, with aquatic vegetation booming and the water ribbon (triglochin sp.) has even started to flower.
- The water is moving swiftly through the forest and the Dissolved Oxygen levels are remaining high, despite dropping slightly in the Pollack Swamp.
- Aquatic vegetation has emerged in the form of nardoo, juncus, matted starwort, water ribbon and many more, which is great to see given that it is the middle of Winter.
- The diversity of aquatic vegetation in such clear water means that the vegetation looks like a planted aquarium!
- Frog calling is ever increasing.
- Colonial waterbird activity throughout the forest is increasing.

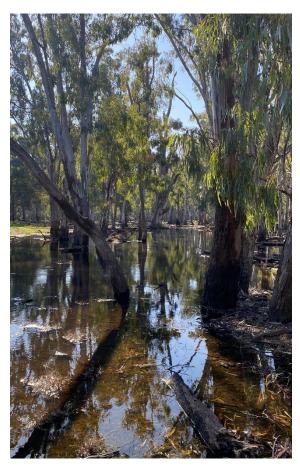
Figure 5. Water running out one of the flood runners at the Pollack Swamp, 03/08/23
