- Flows remain high in our region, close to peak levels, whilst slowly receding
- Exit flows; the Thule Creek depth has dropped quickly whilst the Barbers Creek has dropped slightly
- DO levels remain critically low, the warmer weather has seen DO levels crash again throughout the system
- Ewater refuge deliveries are continuing over the coming week at small rates
- Satellite image from the 6th of November had some cloud but is a fantastic image showing how much of KP is under water...only two sandhills are dry in the whole forest!

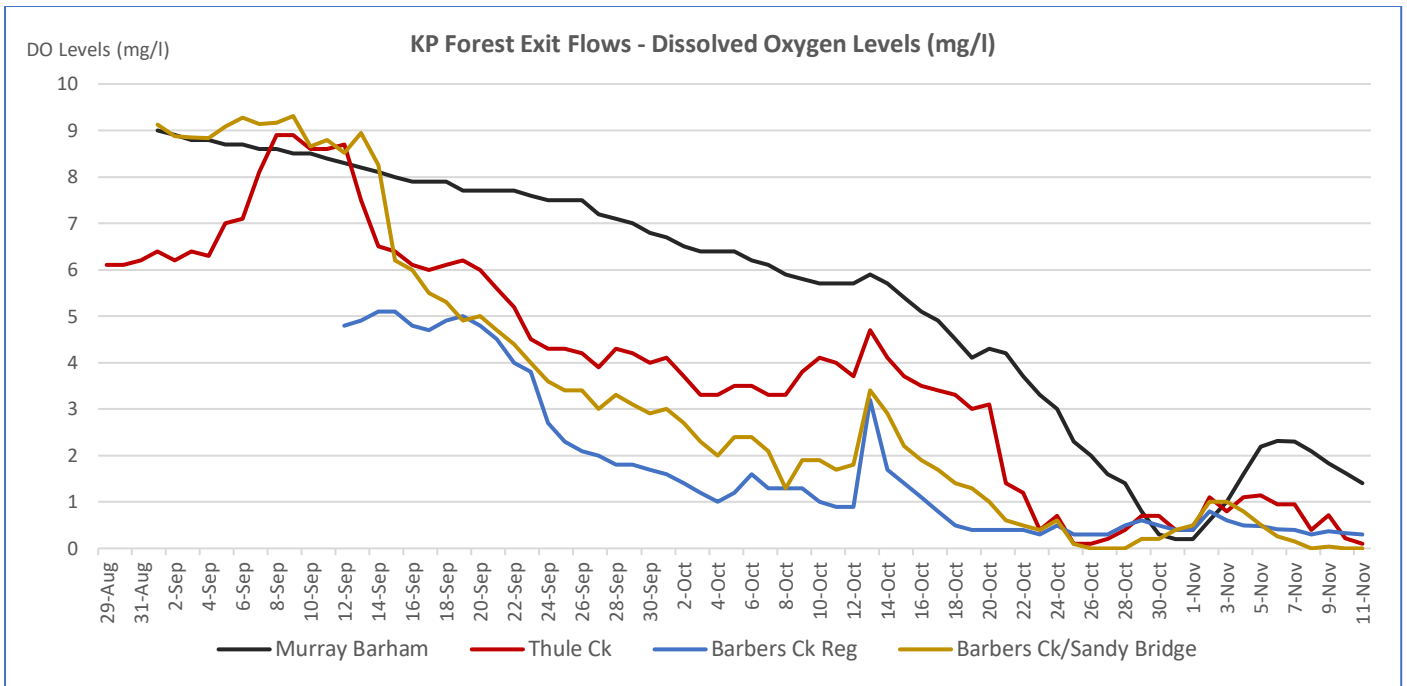
Figure 2: K-P Forest exit flow depths (m) & dissolved oxygen levels (mg/l)
