KPF 2023 OBE Update #6, 16th of August, 2023

Water Flow Rates

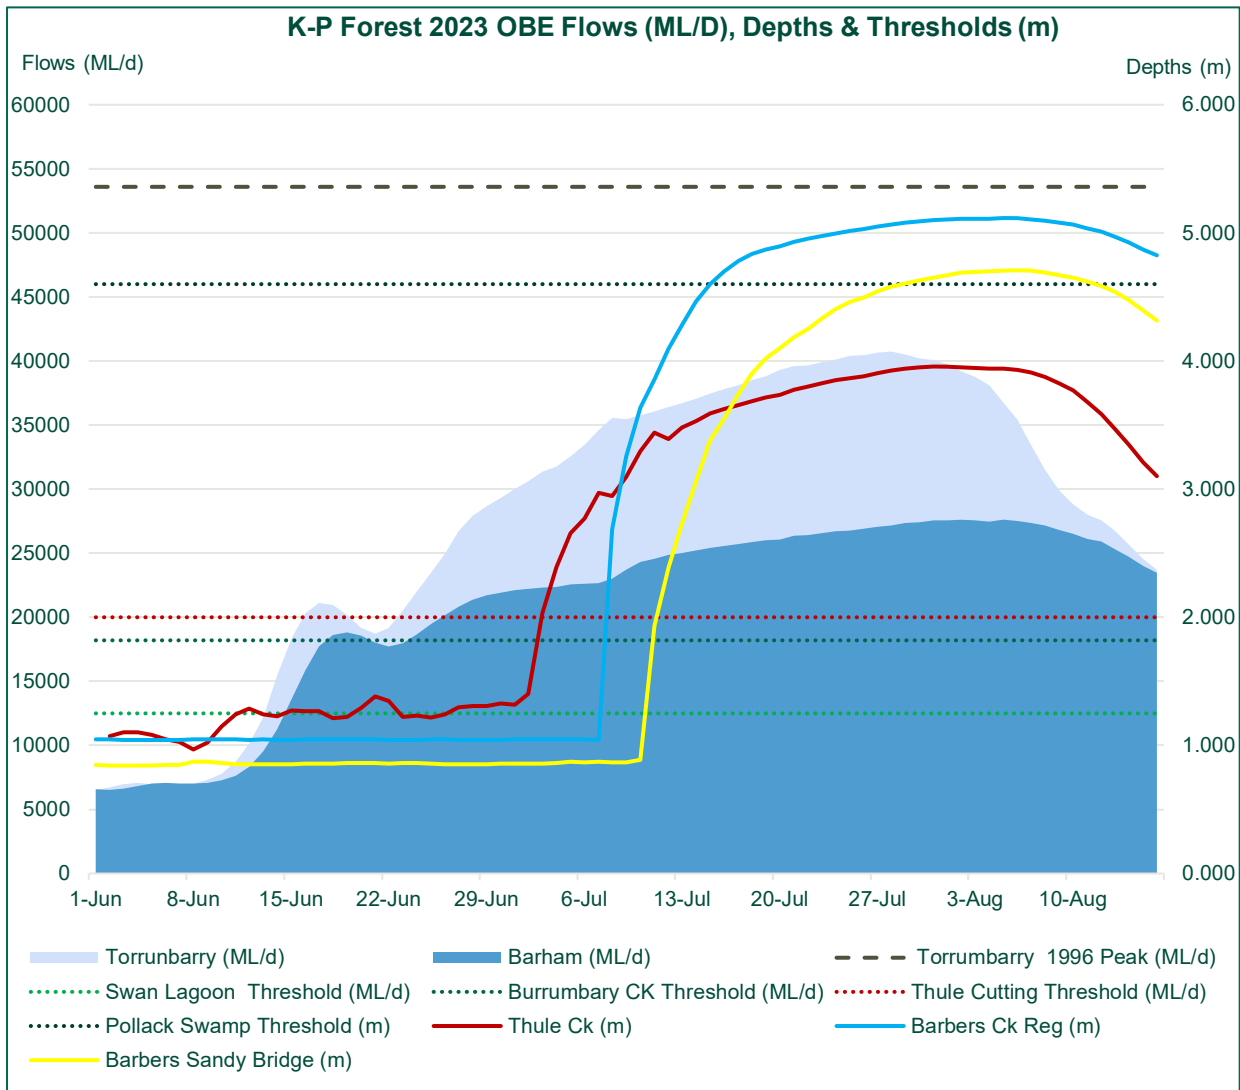
Figure 1: Hydrograph showing Murray River flows (ML/d) and KPF inflow thresholds (ML/d)

- A graph has been supplied that indicates the flows (ML/d) at both the Torrumbarry Weir and Barham township since the 1st of June, the commence to flow thresholds are also depicted on this first graph.
- The second graph supplied depicts the flows in the Murray River, Goulburn River and Campaspe River at key locations since the 1st of June.
- We have another brilliant satellite image from Thursday the 8th of August- I have included a copy of this image below, however; here is the link to the free website if you would like to have a look yourself.

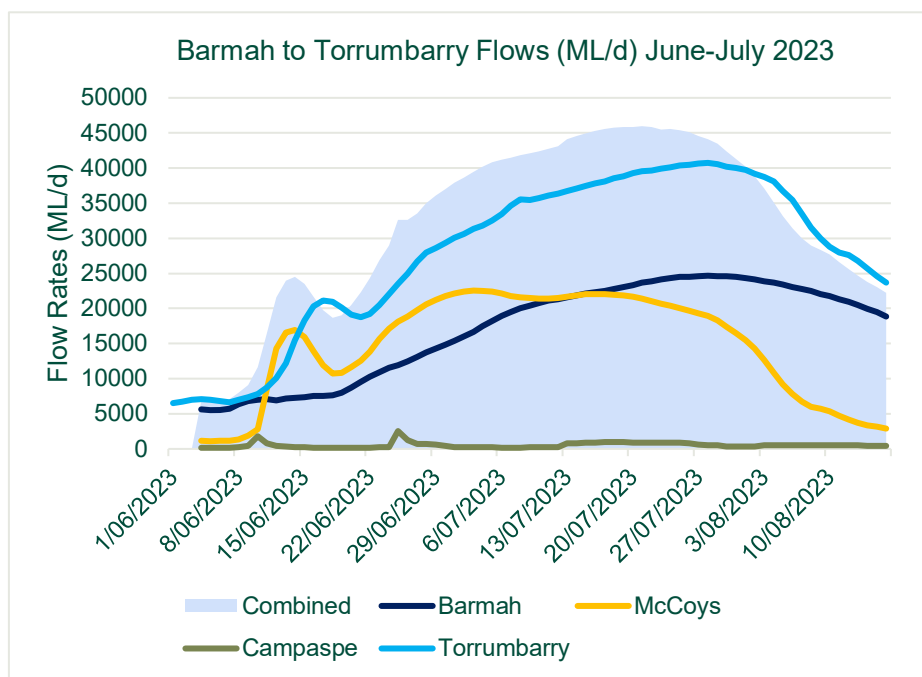
Figure 2: Water flow (ML/d) in the Murray River, Goulburn River and Campaspe River

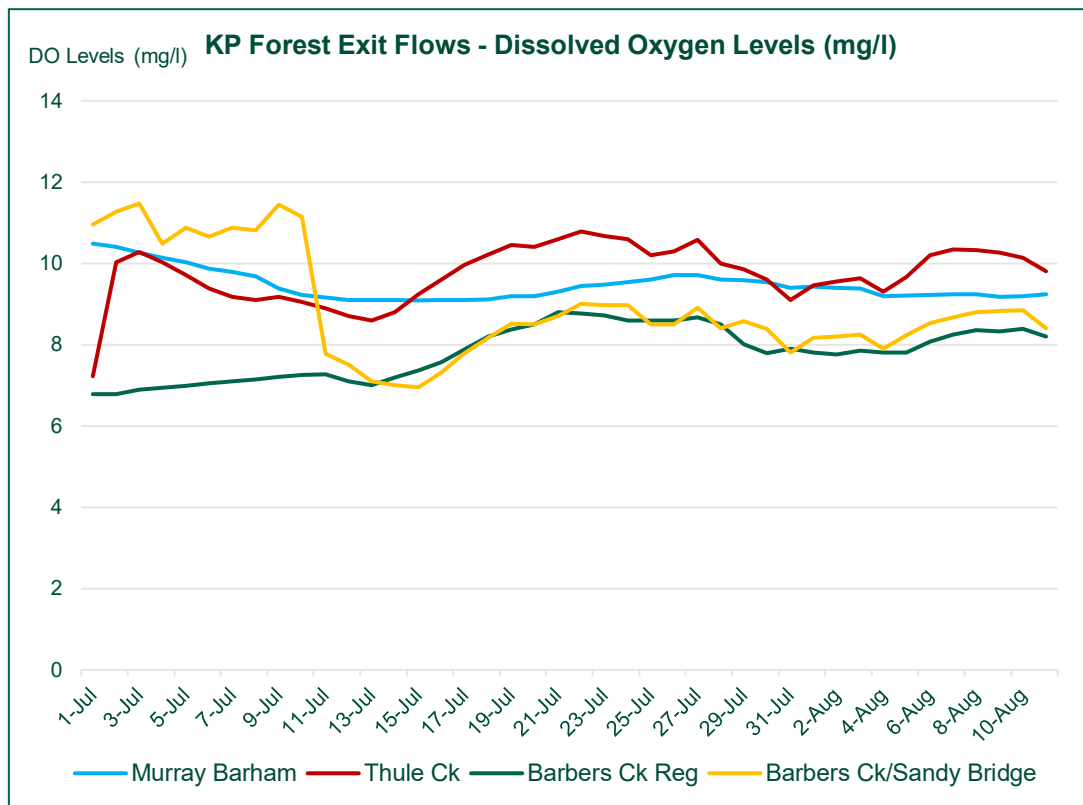
Figure 3: KP Forest Exit Flows, dissolved oxygen levels (mg/L)

- A third graph has been supplied to depict the dissolved oxygen levels (mg/L) in the exit flows from the forest.

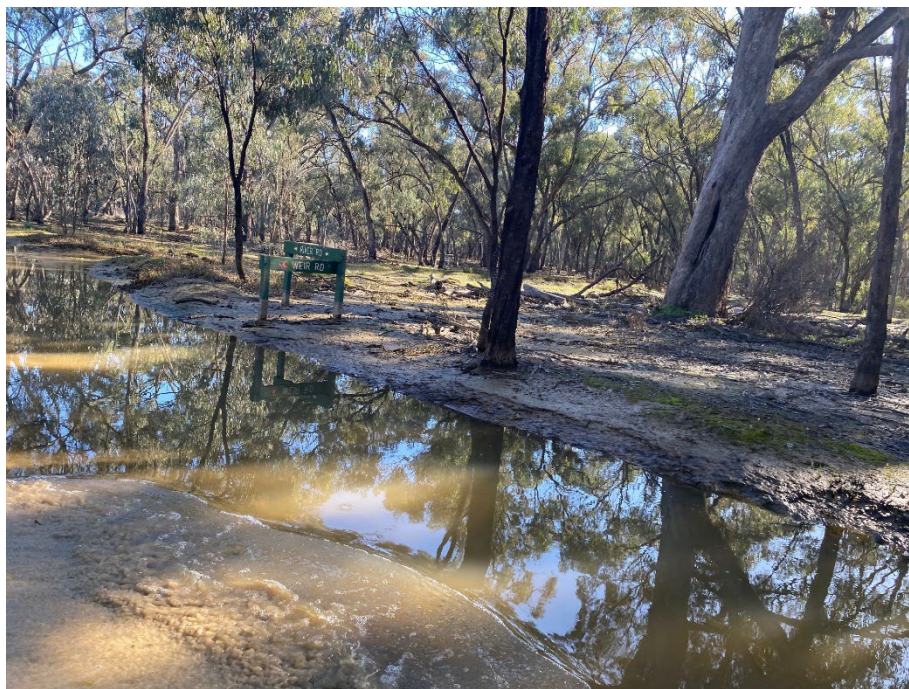
Figure 3. Water receding at Weir Rd 07/08/23

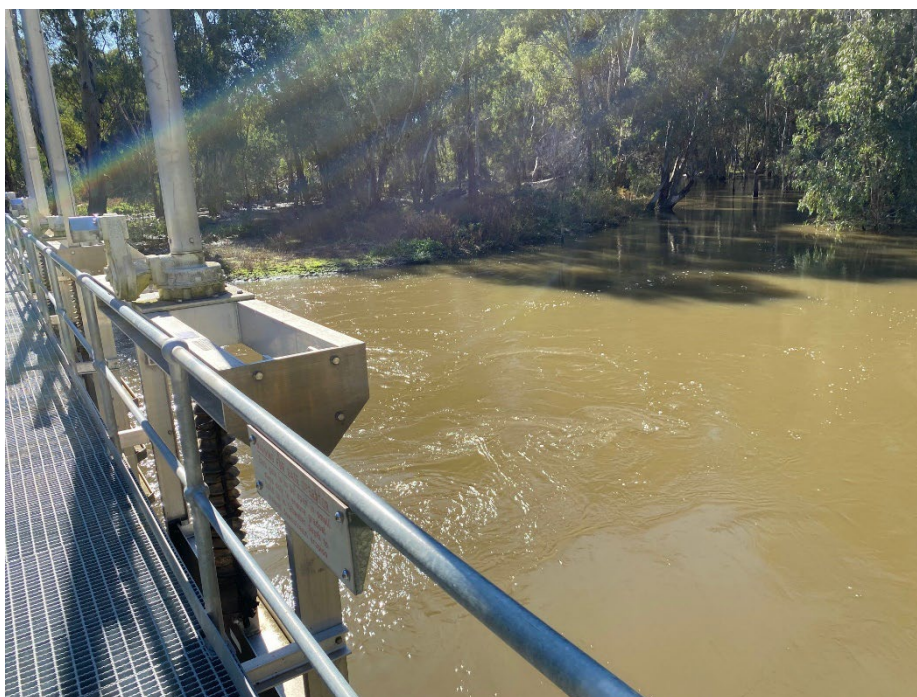
Figure 5. Swan Lagoon inlet regulator 07/08/23
