2022 KPF OBE Water Quality

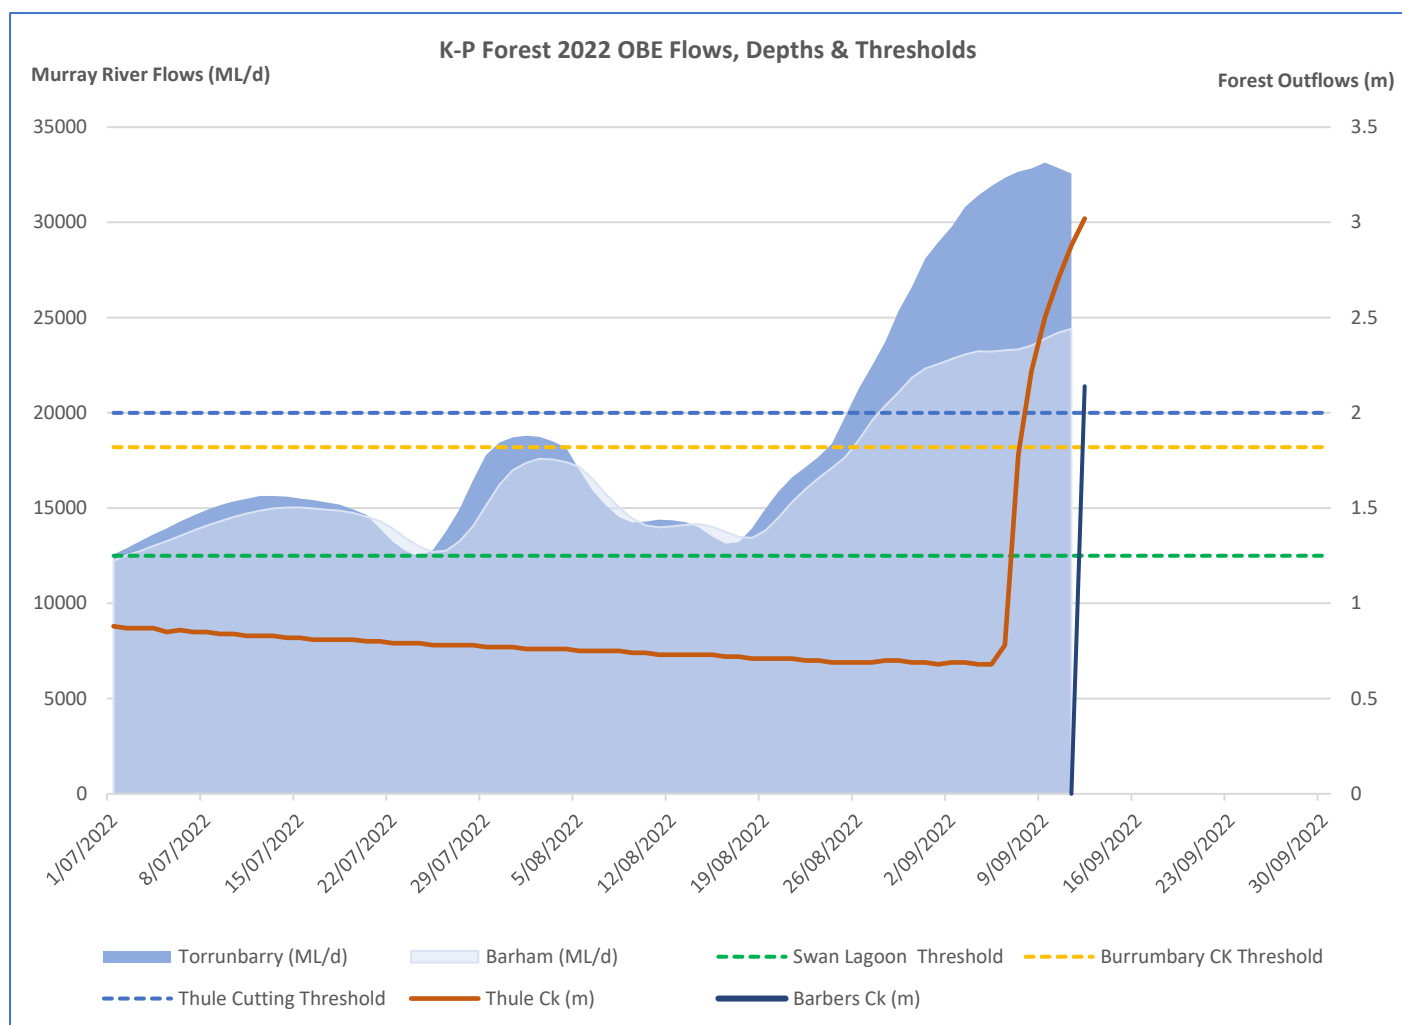
Figure 1: Hydrograph showing Murray River flows and KPF inflow thresholds (ML/d), and exit flows (m)

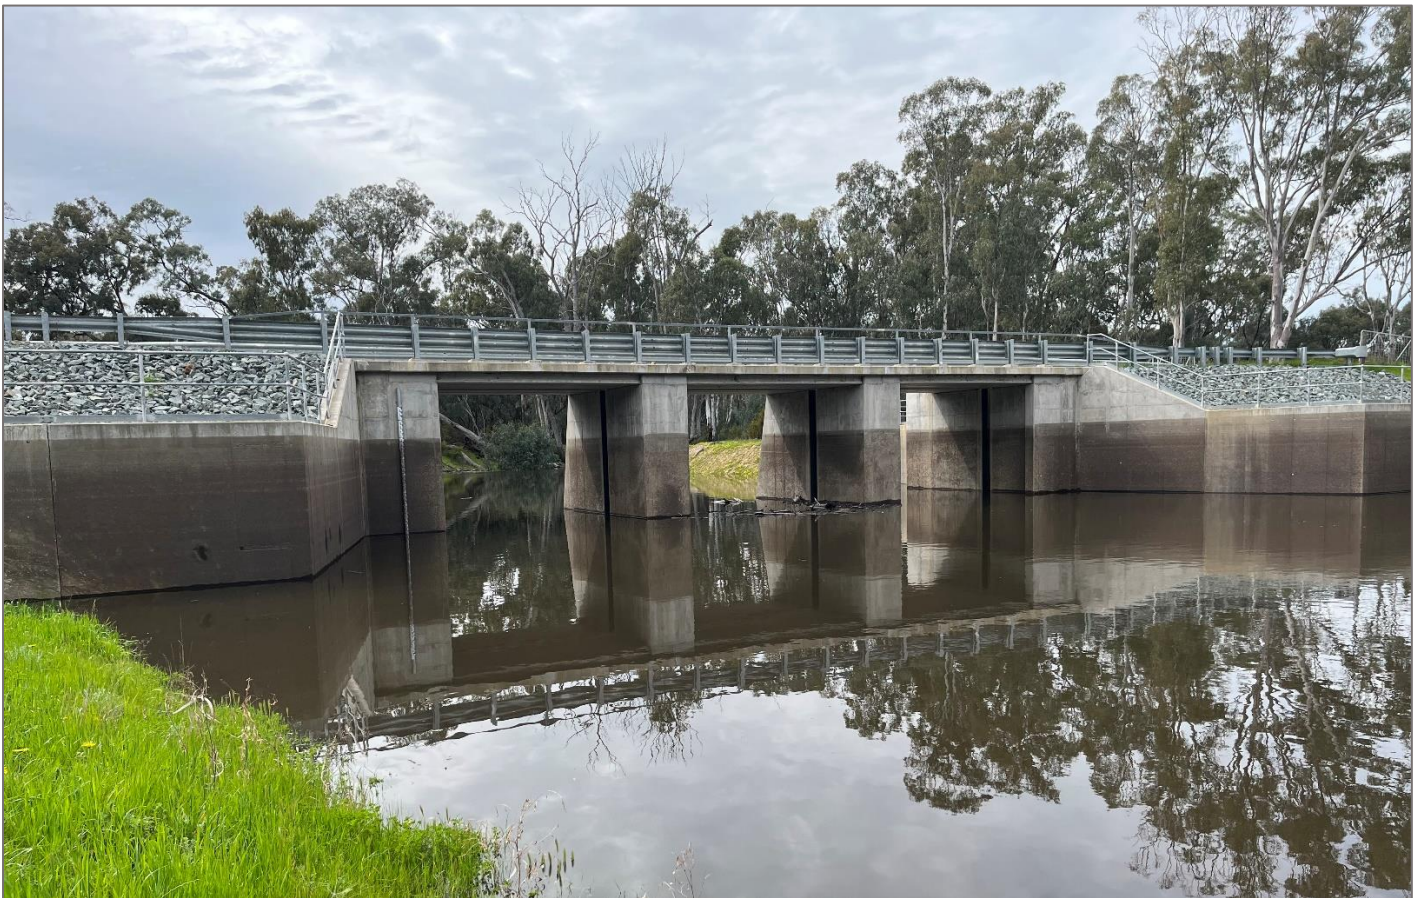
Figure 5: Thule Creek Regulator 7/09/2022
